TEST REPORT No. 343592

Purpose of test: uniform snow load on a shelter

The test specimen is called "LA PENSILINA-ES".

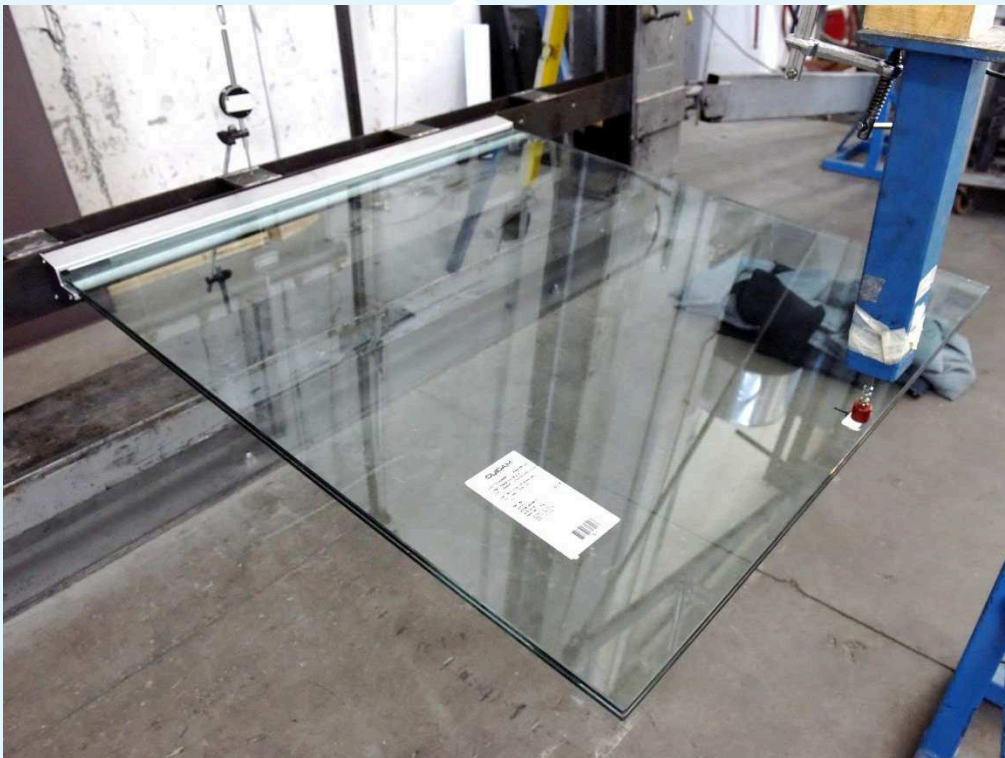
Specimen photo

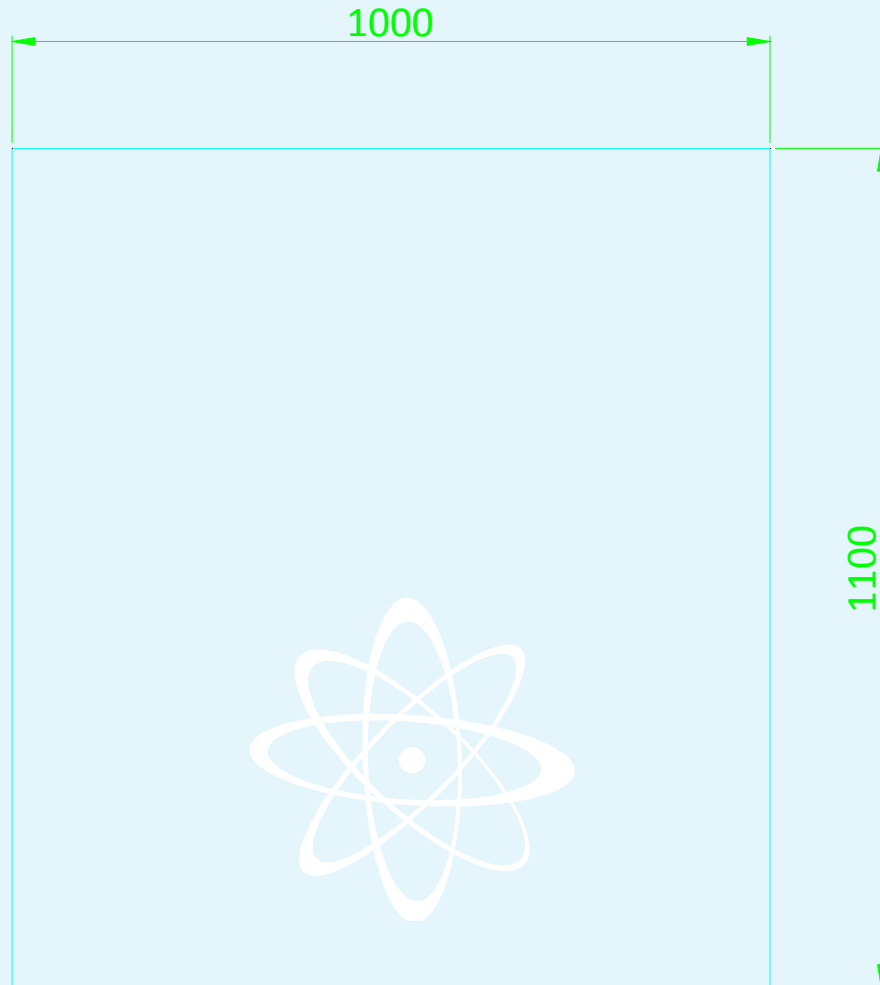
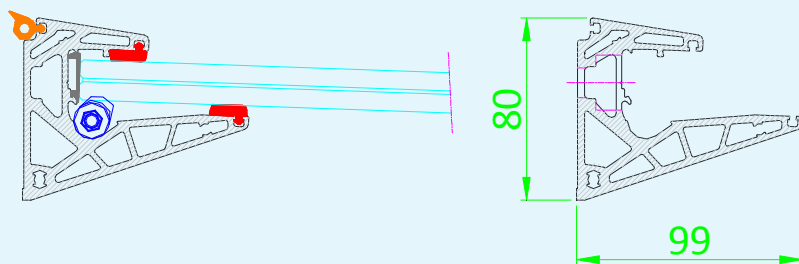
The test specimen is a shelter consisting of:

- glazing panel comprising 8.8.2 Float ES laminated glass, nominal length 1000 mm and nominal projection 1100 mm;
- aluminium fixing system.

Specimen

Further details of specimen specifications can be seen in the Customer-supplied schematic drawings on the next page.

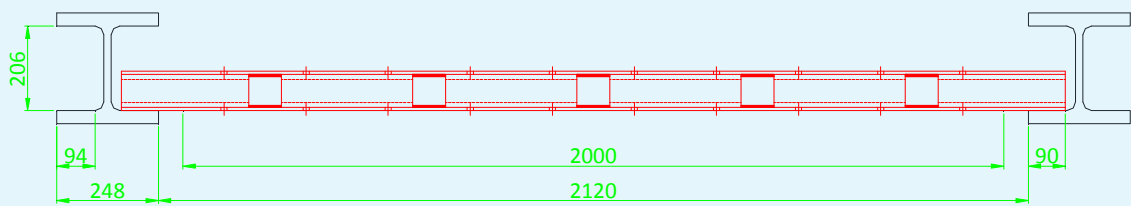
The specimen also has a test frame in which it was installed by the Customer at 5 fixing points using steel nuts and bolts.

Test frame

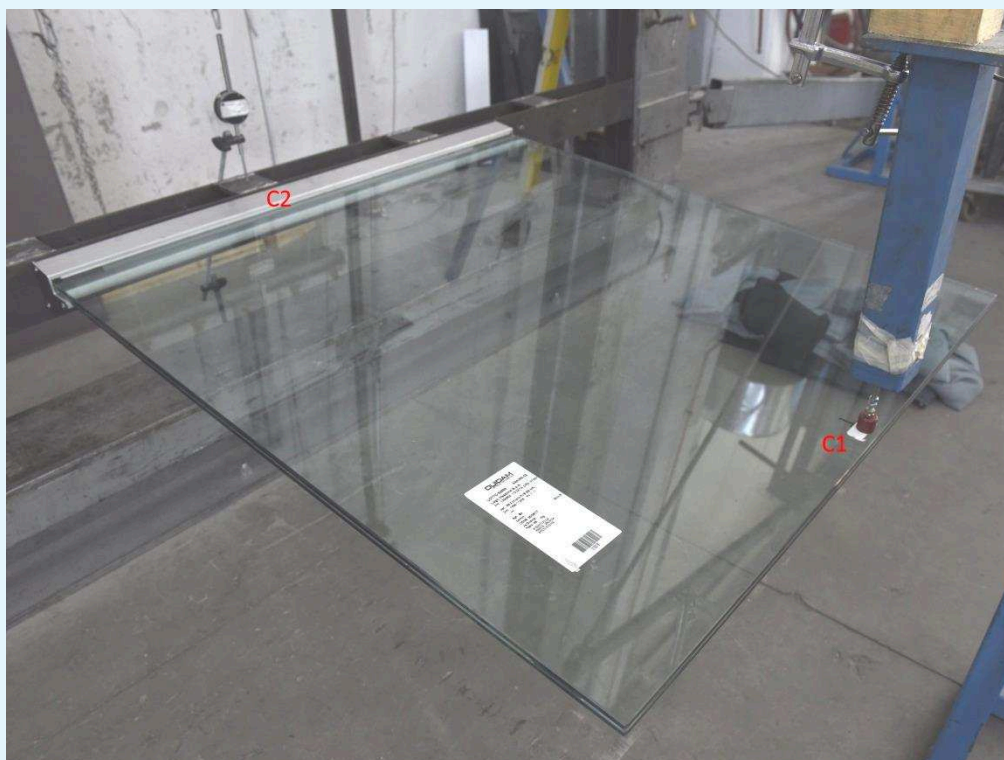
Specimen photo showing measuring points

After positioning the loading mass, deflection was measured at each load step using the two displacement gauges with 0,01 mm resolution arranged as shown in the photo on the next page.

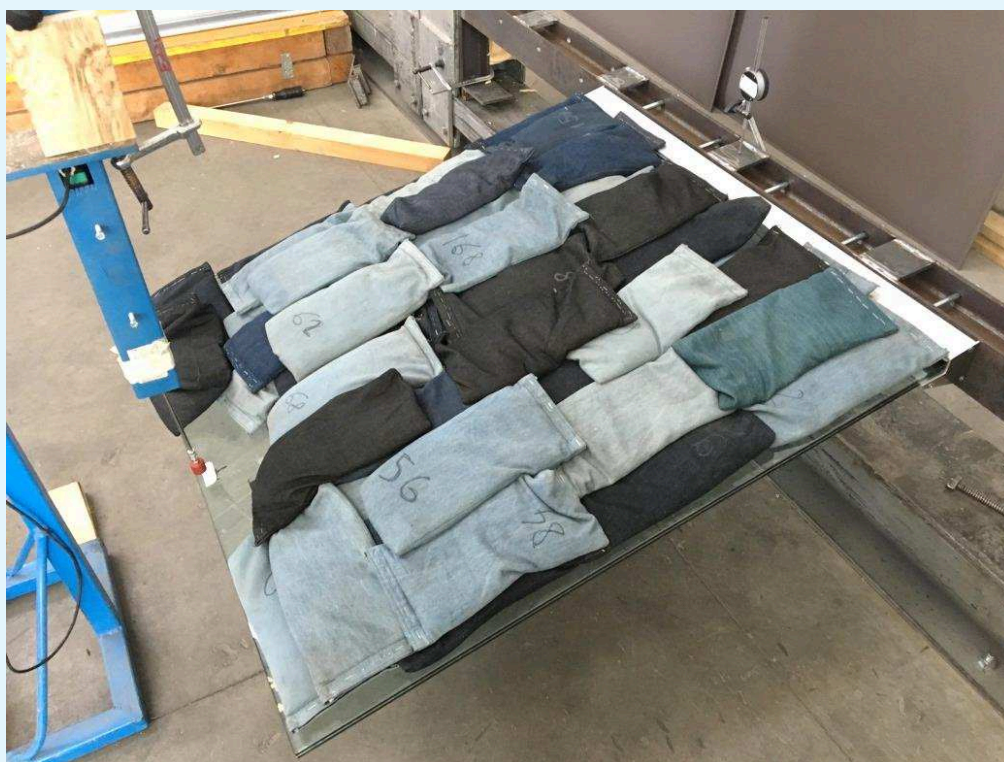
Photo of specimen during test

The test was carried out in accordance with Customer instructions, securing the specimen to the test rig using its test frame and applying a uniform load to the glazing panel using the loading mass.

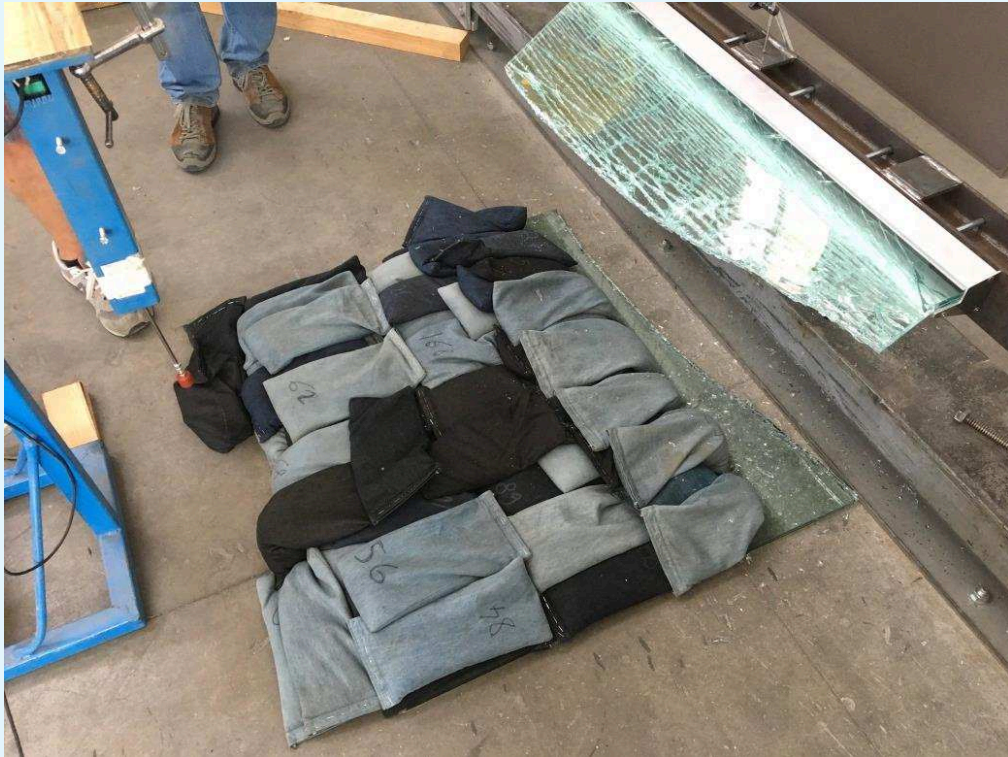
Specimen after-test photo

Length "Z" [mm]	Projection "L" [mm]	Ultimate load	
		[kg/m ²]	[kN/m ²]
1000	1100	365	3,25
