TEST REPORT No. 343590

Purpose of test: uniform snow load on a shelter

The test specimen is called "LA PENSILINA-SG".

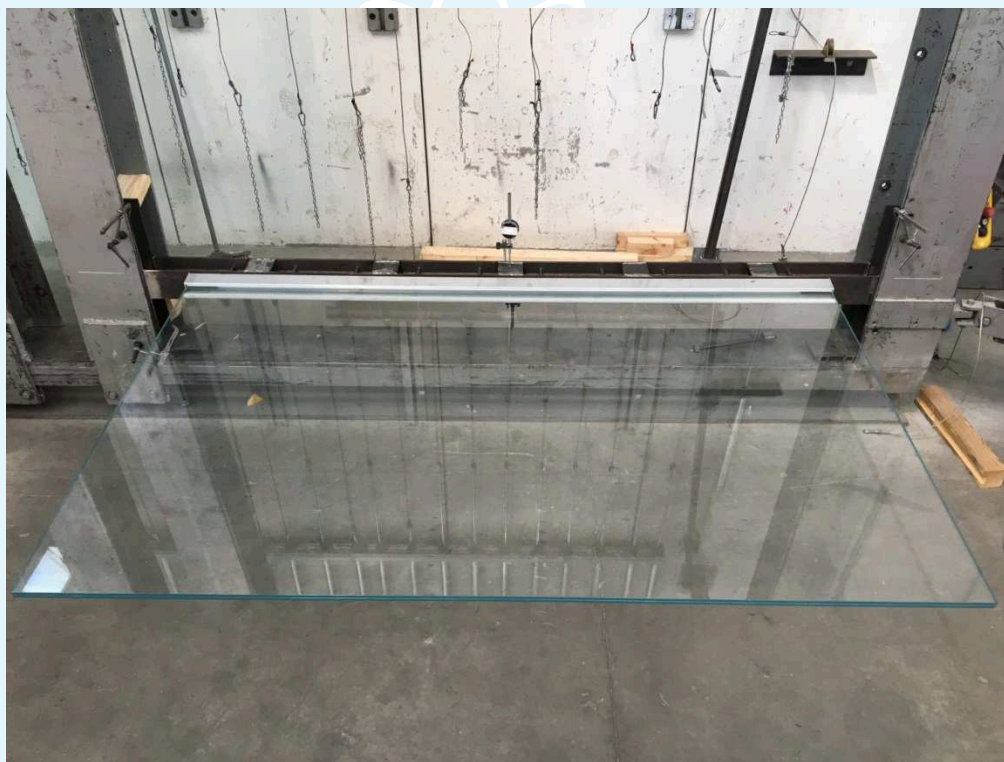
The test specimen is a shelter consisting of:

- glazing panel comprising 8.8.4 SentryGlas® (1,52) laminated glass, nominal length 2000 mm, nominal projection 1200 mm and nominal thickness 17,52 mm, formed by 2 panes of toughened glass, nominal thickness 8 mm each, with plastic interlayer, overall nominal thickness 1,52 mm;
- aluminium fixing system.

The specimen also has a test frame in which it was installed by the Customer at 10 fixing points using steel nuts and bolts.

Specimen photo

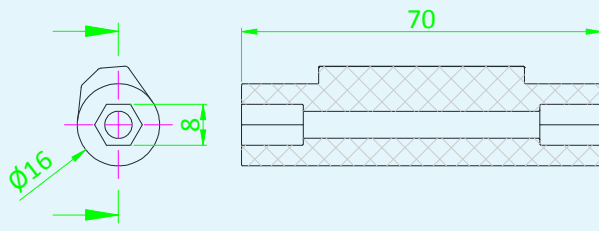
Cam

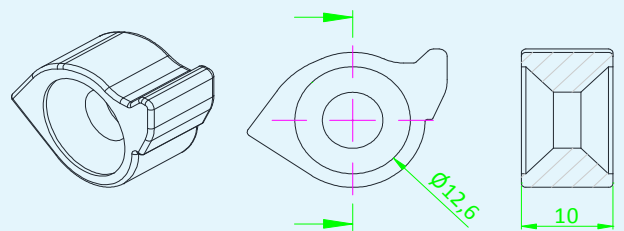
Safety catch

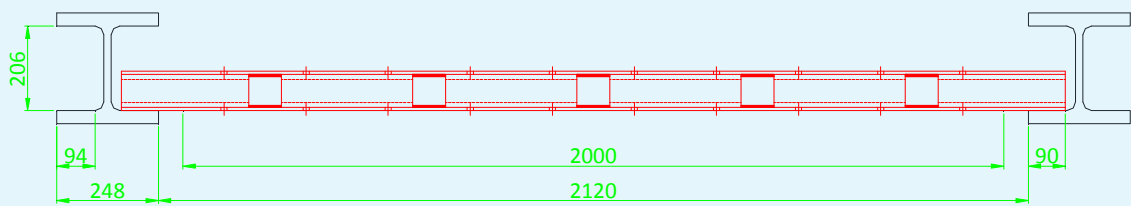
Test frame

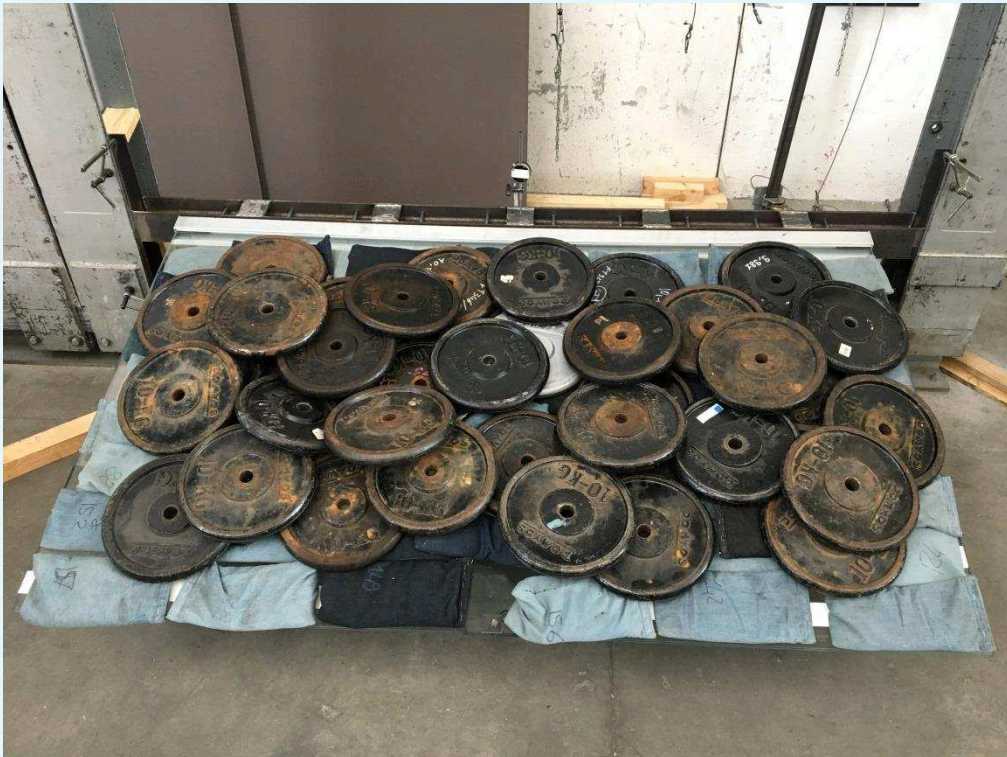
The test was carried out in accordance with Customer instructions, securing the specimen to the test rig using its test frame and applying a uniform load to the glazing panel using the loading mass.

Photo of specimen during test
